# Welding electrical hazards: an update

David A. S. Hisey

Received: 23 October 2012 / Accepted: 9 September 2013 / Published online: 31 October 2013  
© International Institute of Welding 2013

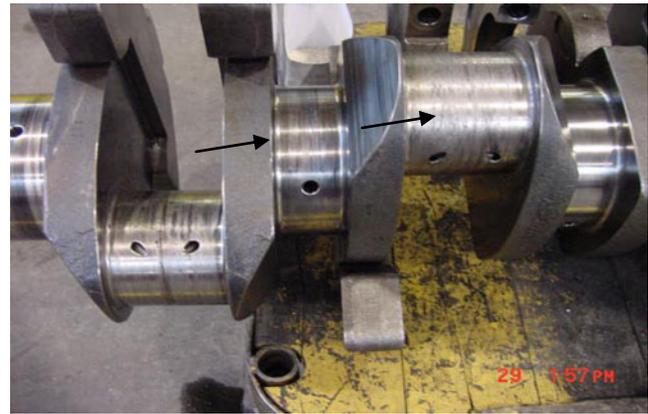
**Fig. 1** The welding current entered or exited the engine through the crankshaft during maintenance welding on the haul truck box and frame areas. The bearing journal in the center is a main bearing journal; the one to the *right* is connecting rod bearing journals. This engine was configured as V 16, so there are two connecting rods on a common journal

However, if the equipment is stopped when the welding current flows across a bearing race, then the damage will be similar to that noted on the main bearing caps of the hauler engine, definite arc flash pits. When the bearing is disassembled, it can be examined with a 10–30 power-magnifying glass. Welding current will appear in an antifriction<sup>13</sup> bearing as pitting with smooth bottoms which are typical of any electrical metal arc. A before and after vibration analysis will quickly show up the change which has occurred in a bearing which has suffered welding current damage. Like all failures, identifying failure early, before total destruction, helps the investigator greatly in identifying the cause, and therefore the solution.

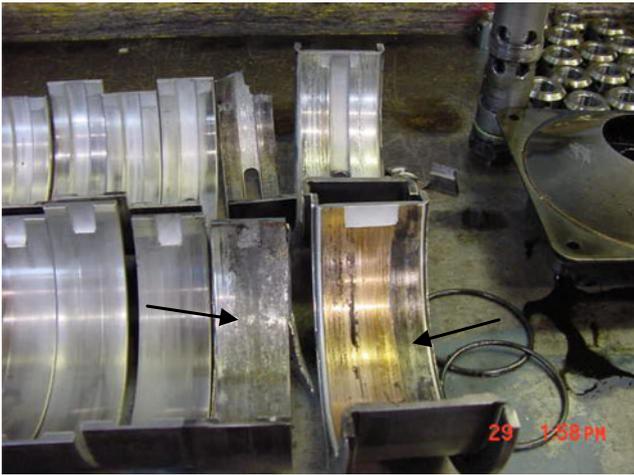
**Fig. 2** Bearing inserts shown here. From the right, main bearing, then connecting rod bearings. The first 2 bearing inserts have seen heavy current flow

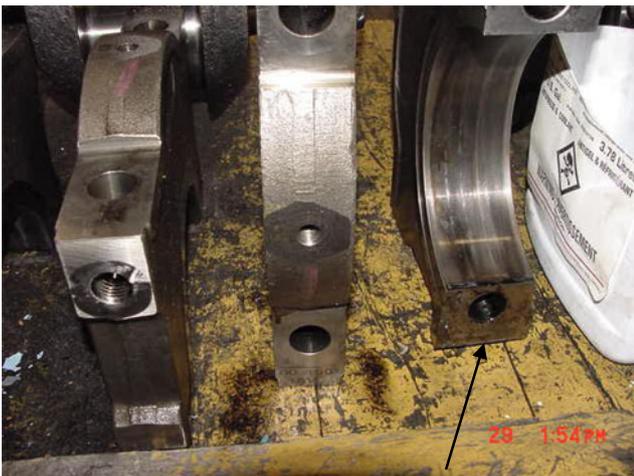
**Fig. 3** This is a phenomenon which has occurred repetitively in large diesel engines damaged by stray welding currents. Welding arc is present on the mating surfaces of main bearing journals and the engine block even though these are tightly torque bolted joints

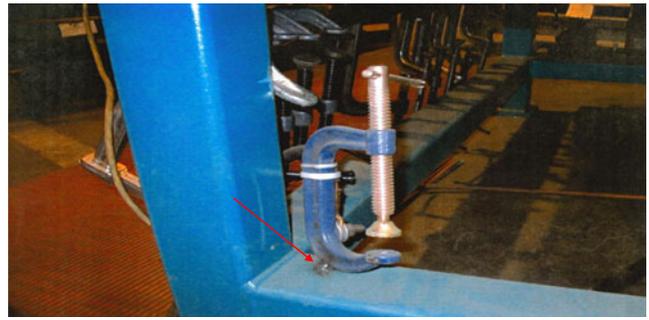
**Fig. 4** This standard “C” clamp is only tack welded to the welding work bench. Based on a 4 V drop, a 60 m length of 4/0 AWG welding cable will carry 400 A of welding current, the tack weld will carry much less, forcing the excess current to flow elsewhere to get back to the welding machine if there is an alternative “parallel” path. This situation was found in the Ontario, Canada manufacturing facility

Multiple paths existed for the various welding currents from the numerous welding machines. These failures become additive and the whole building structure became alive with a multiple of current paths. Applying OHM's law (voltage= resistance $\times$ amperage), the resultant voltage difference was viewed as electric arc flashes when the metal safety harness lanyard touched two different sections of building structural steel (Figs. 4, 5, 6, 7, 8, and 9).

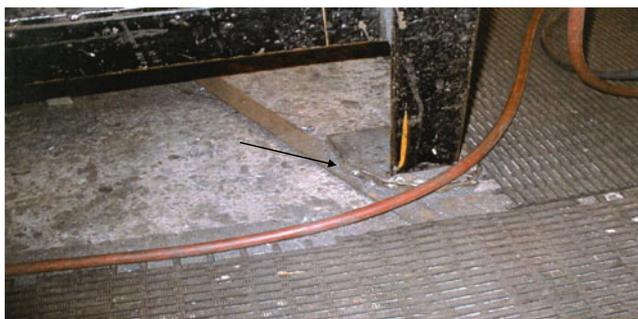
**Fig. 5** Multiple welding machines were connected to a common return flat bar. Here, we see the circuit passing by another work station so the work bench leg was simply welded to the 11-gauge flat bar. This situation was found in the Ontario, Canada manufacturing facility

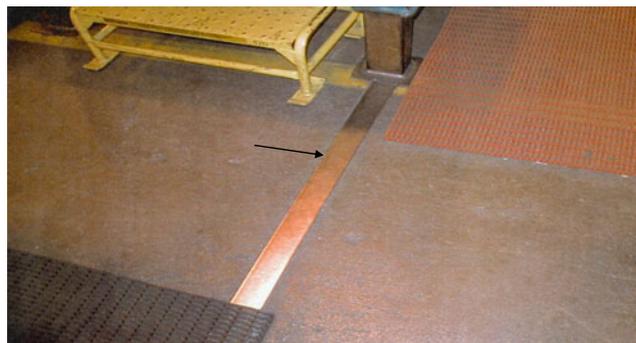
**Fig. 7** Well-designed, very neat installation; however, this 11-gauge steel flat bar would not carry equivalent current to a 4/0 copper weld lead, so the excess current found another parallel path. This situation was found in the Ontario, Canada manufacturing facility

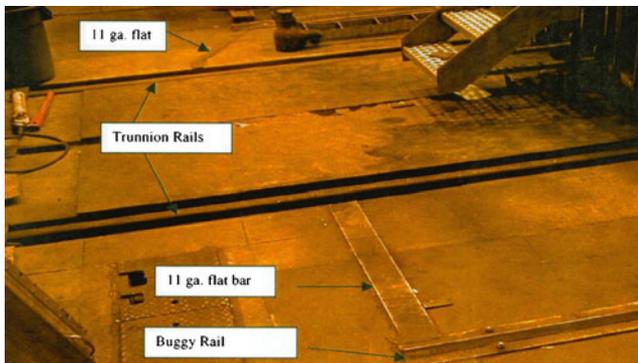
**Fig. 6** More 11-gauge flat bar intended to replace 4/0 AWG copper welding cable. It will not carry the equivalent current, so the excess current found another parallel path. This situation was found in the Ontario, Canada manufacturing facility

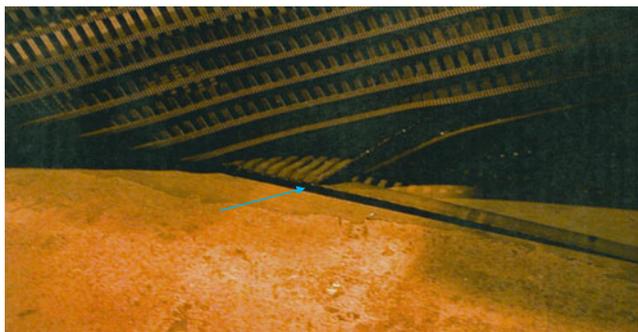
**Fig. 8** The steel 11-gauge flat bar had overheated and the rubber floor matting had melted and stuck to the flat bar. This situation was found in the Ontario, Canada manufacturing facility

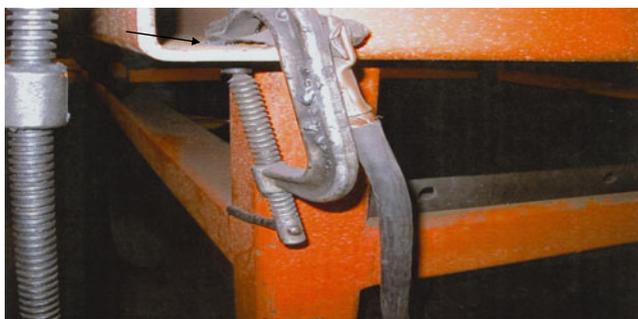
**Fig. 9** Arcing can be seen at the point of contact where the standard “C” clamp is in contact with welding work bench steel, visually demonstrating the lack of good contact. This situation was found in the Ontario, Canada manufacturing facility

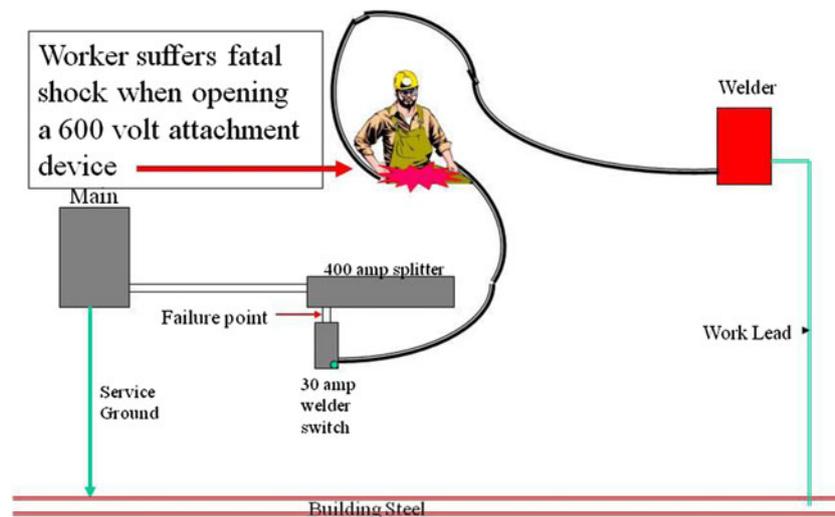
**Fig. 10** Two things occurred simultaneously; the electrician was researching the power failure and the welder was trouble shooting his welding machine. After the main power had been restored on a faulty circuit feeding the welding machine, the welder

disconnected the male/female cord connector feeding the welding machine. Due to the initial fault in the electrical service feeding the welding machine, the welder received a 347 VAC shock at 400 mA across his chest and died

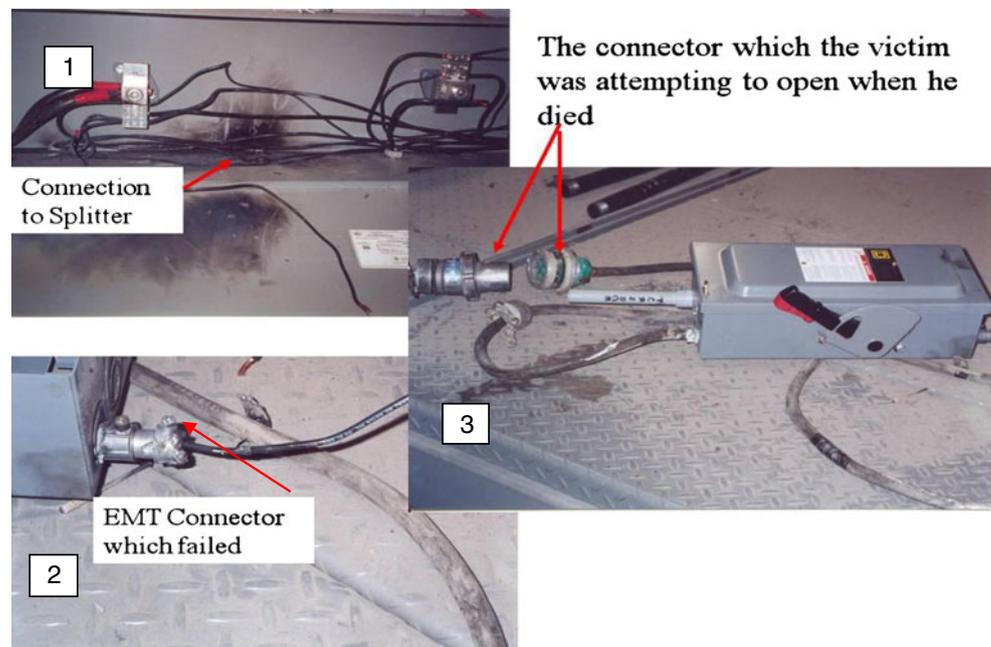
**Fig. 11** The electrical conduit connection which melted due to stray welding current flowing through it. The molten metal caused the insulation on the electrical wiring to fail. 1 The electrical splitter where the conduit in 2 was originally installed at the time the stray welding current began to flow. The *black area* in 1 is from the electrical explosion when the #10 AWG copper phase conductors contacted the grounded metal electrical splitter box (see picture #4 below)

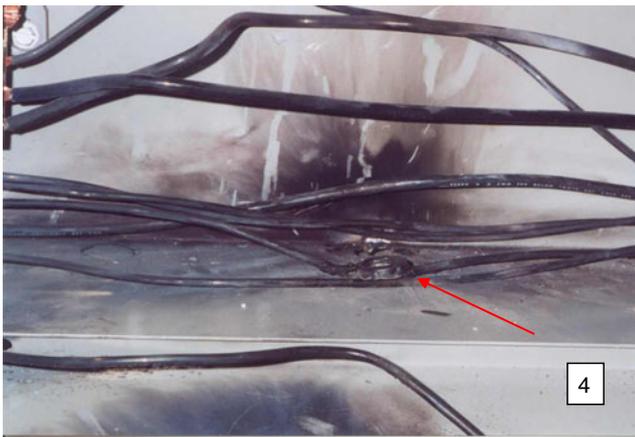
**Fig. 12** 4 This is a close-up of the damage shown in 1 of Fig. 11. The red arrow indicates the location the partially melted conduit shown in 2 of Fig. 10 had been installed. Notice the localized melting of the insulation on the electrical wiring

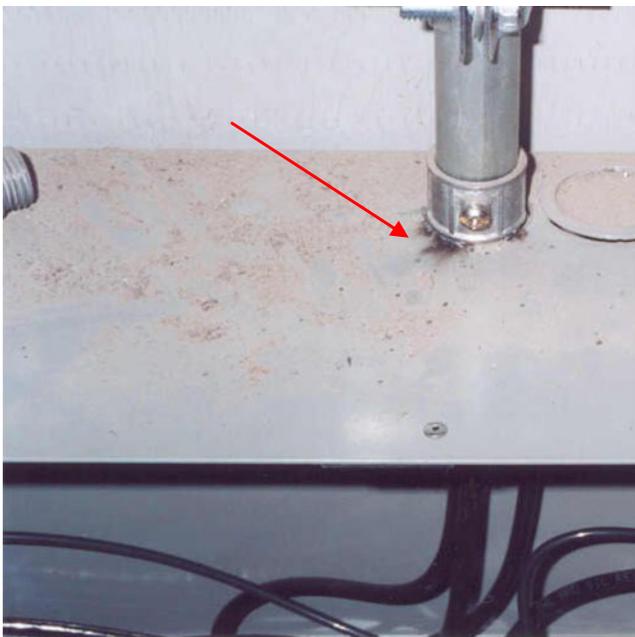
**Fig. 13** Signs of stray welding current are seen in this picture. This electrical circuit was part of the building electrical system, but not a part of the electrical circuit feeding the welding machine

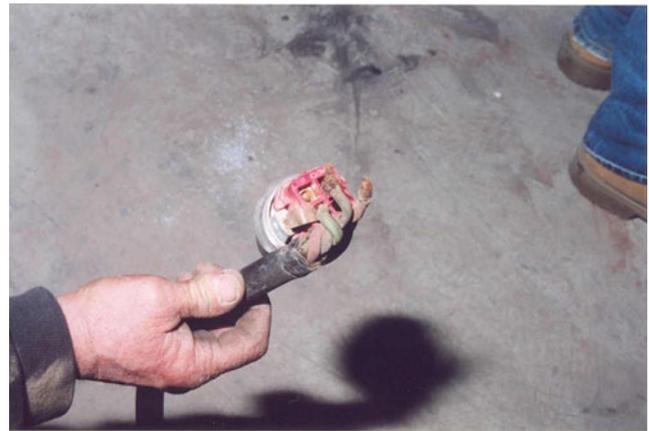
**Fig. 14** Inspection of the cord connector supplying power to the welding machine revealed electrical insulation was in normal condition. Excess welding current flow would be expected to cause over heating damage

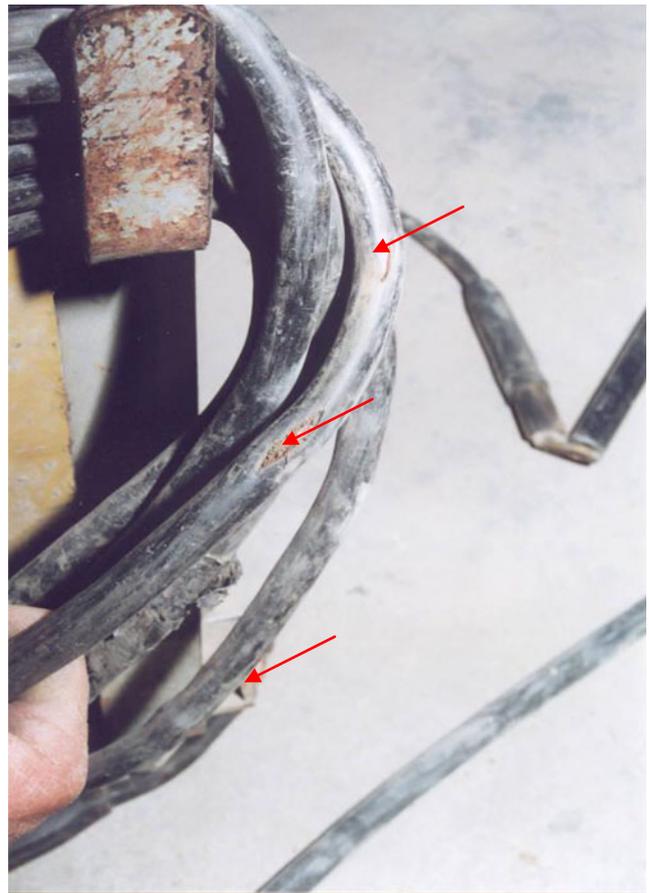
**Fig. 15** The arrows point to bare places on the welding electrode cable which was found in use on the work site. Welding cable is an electrical conductor and as with any electrical conductor, must have good insulation qualities. The welding current may have exited the welding cable and entered other current paths (Note that electrocution can occur from contact with just one strand of wire in a welding cable. Welding currents are at least three orders of magnitude higher than currents that are lethal.)

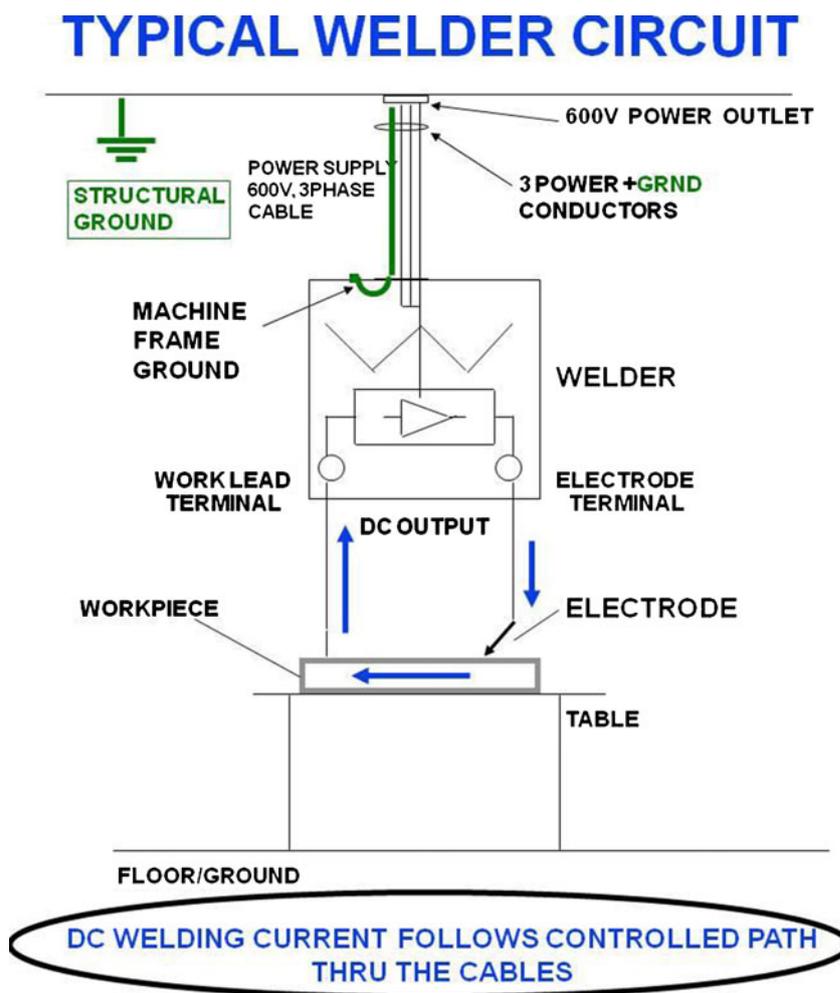
Fig. 16 Typical welder circuit

within a designed welding circuit. Welding machines are designed with two welding leads; those leads should be bundled together and taken to any weld location as one lead. Where the electrode lead goes the return lead shall also go. It is a policy which should be enforced on all worksites.

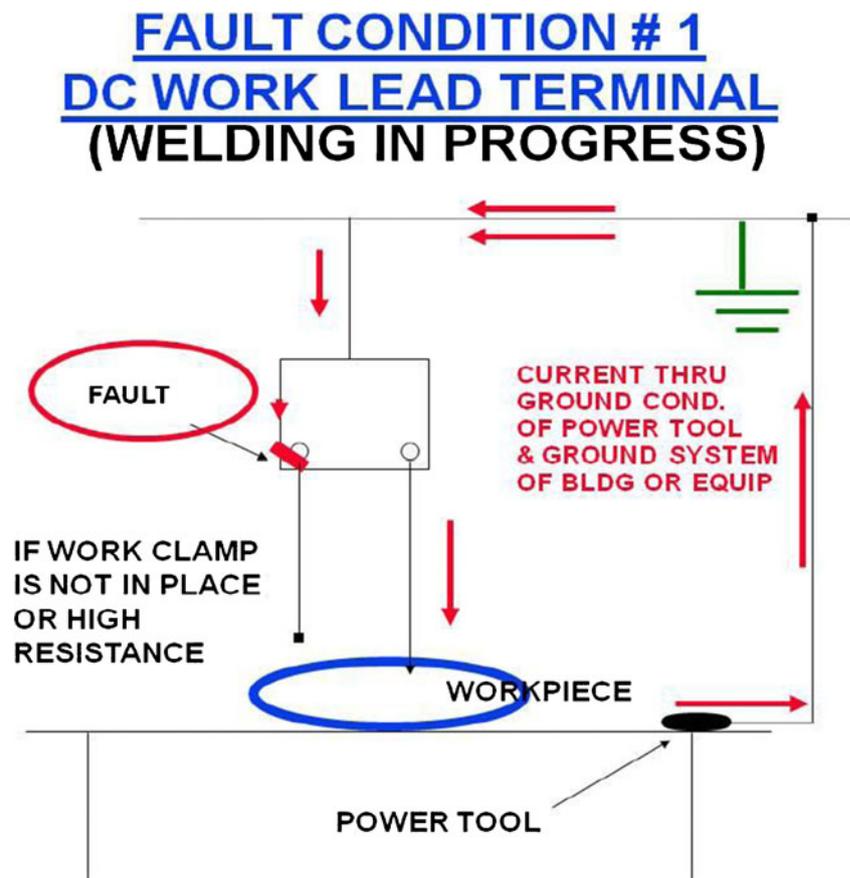
**Fig. 17** Fault condition #1, DC work lead terminal (welding in process). This drawing describes a stray welding current situation. This drawing also depicts a power tool lying on the work bench which for a welder would typically be a grinder which is used constantly in the welding trade

In Fig. 17, which we choose to call fault condition #1, we depicted a connection between the work lead terminal and the frame of the welding machine, this could be an intentional

connection, it could be accidental as the work lead is often coiled as a loop on the side of the welding machine with the work lead clamp touching the welding machine metal frame. This situation can also arise if there is damaged insulation on the work return cable. It is assumed in this drawing that the power tool is electrically grounded.

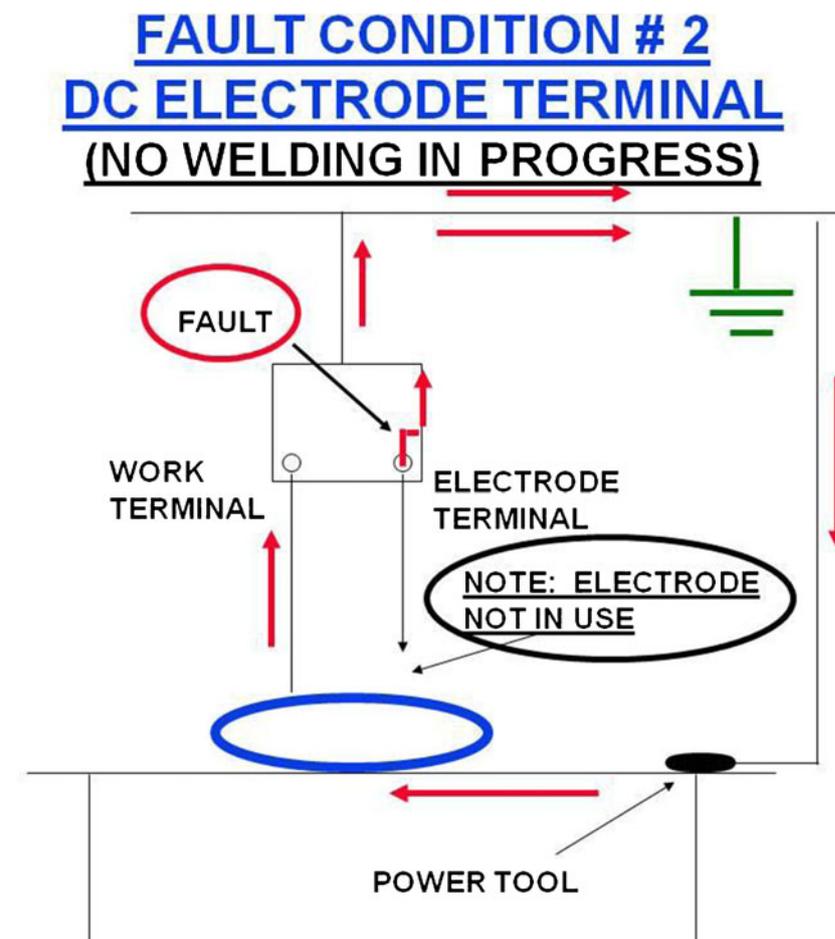
**Fig. 18** Fault condition #2, DC electrode terminal (NO welding in process). This drawing describes a stray welding current situation

In Fig. 18, which we chose to call fault condition #2, a connection between the electrode lead terminal and the frame of the welding machine is depicted. This is not a condition that anyone expects to occur, yet it was found to be a very common condition anywhere welding is occurring. It could be caused by a welding machine connected for dual purpose operation with a wire feed (MIG) gun sitting in a welding machine

mounted holder and the welding machine set to MMAW/SMAW mode, which would cause all connected equipment to be alive at electrode voltage. The MIG cup holders originally are insulated but over time they may become contaminated, chipped and contact with ground usually as a high resistance connection allows partial welding current to flow undetected.

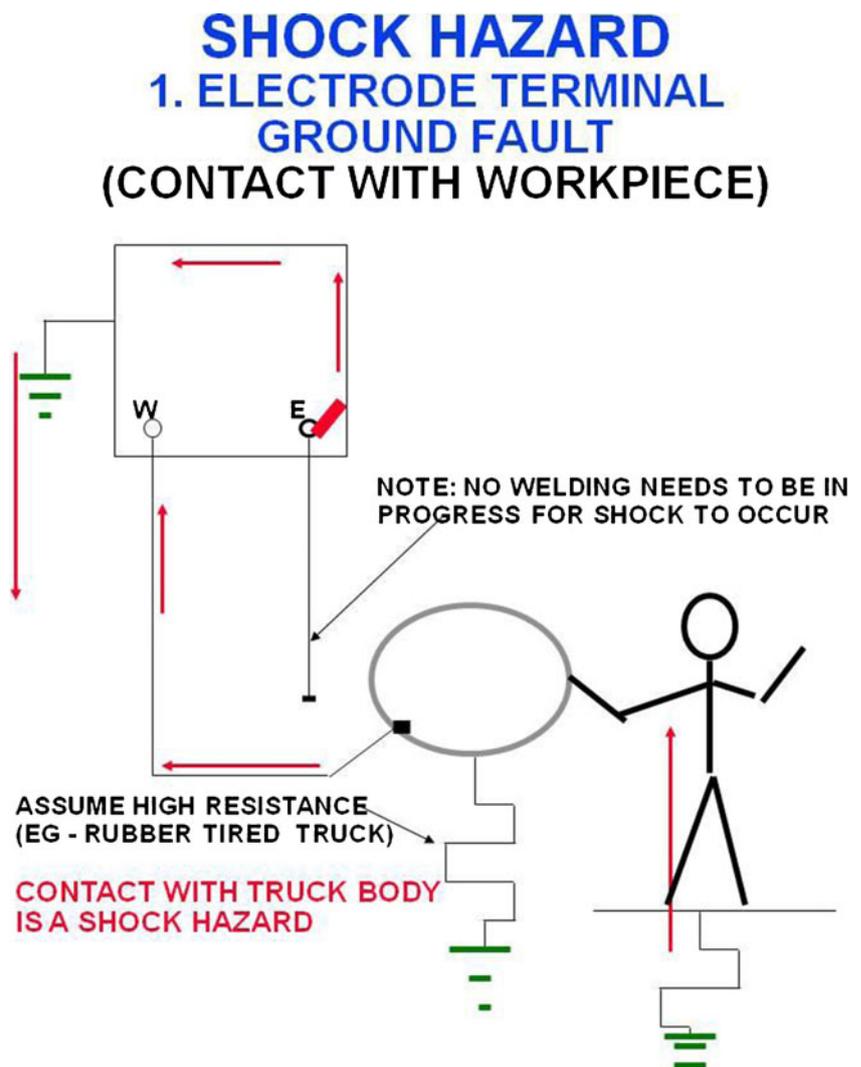
**Fig. 20** Electrode terminal ground fault (contact with workpiece). A worker caught in this situation is set up to receive a full open-circuit voltage electrical shock from the welding machine.

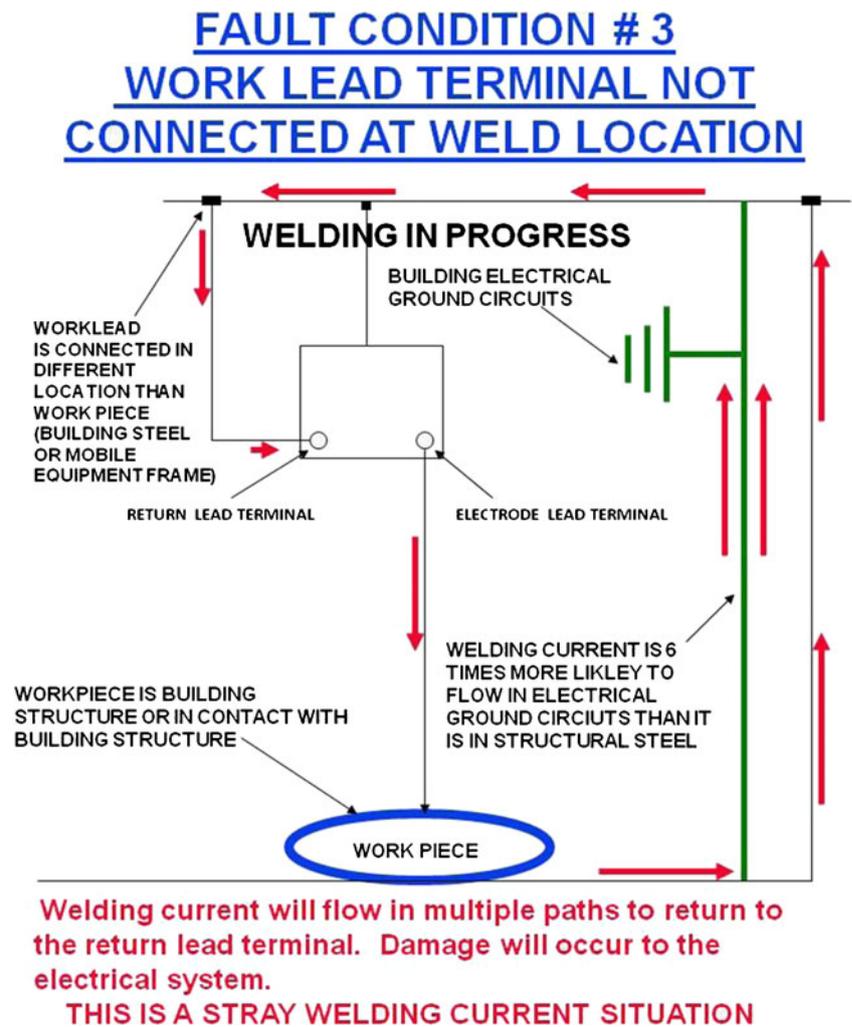
**Fig. 21** Fault condition #3, work lead terminal not connected at weld location. This drawing describes a typical stray welding current situation
